REMEDIAL ACTION PLAN

8920 LAISY AVENUE & 3420 EAST 93RD STREET CLEVELAND, OHIO 44104

OCTOBER 1, 2024

THE MANNIK & SMITH GROUP, INC. 1800 INDIAN WOOD CIRCLE MAUMEE, OHIO 43537

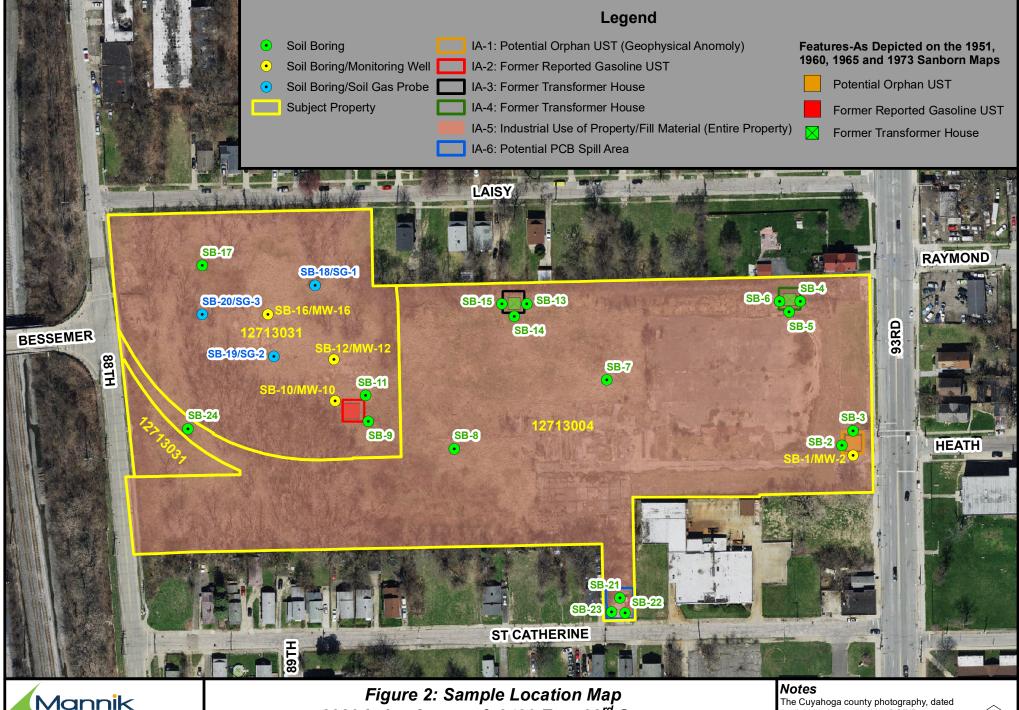
Figure 2: Sample Location Map 8920 Laisy Avenue & 3420 East 93rd Street Cleveland, Ohio
